| Project: AB-2 | | Problem Area Summary |
| Lake Segment | Malletts Bay Direct | |
| Location | Allen Drive | |

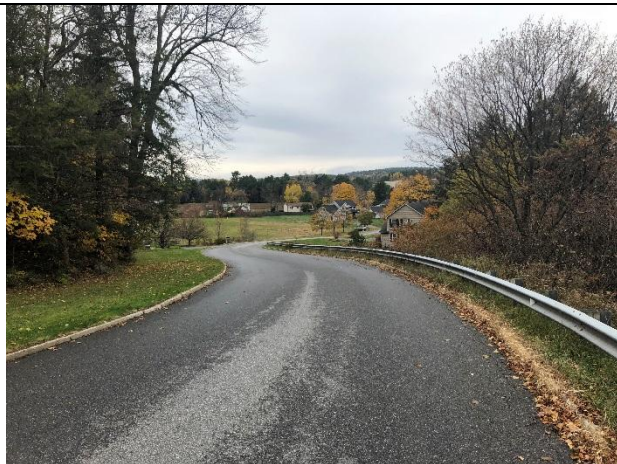
**Site Description:** Two storm lines draining a wide residential road empty directly to Allen Brook. The eastern drainage is very steep and flows down a rock lined ditch with some gully erosion near the brook.

**Photo 1:** Top of drainage looking west towards Allen Brook

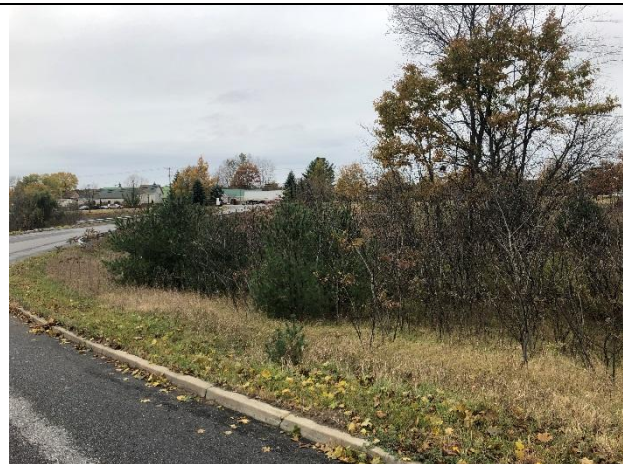
**Photo 2:** Location of proposed infiltration BMP – terrace located along the side of road above floodplain.

**BMP Description:** Route runoff from the two catchbasins to a new infiltration feature located on the terrace north of the road. The infiltration feature will have a stone lined overflow spillway to the floodplain. Underlying soils are mapped as having a high infiltration rate. **Subsurface infiltration may be possible for additional treatment volume.**

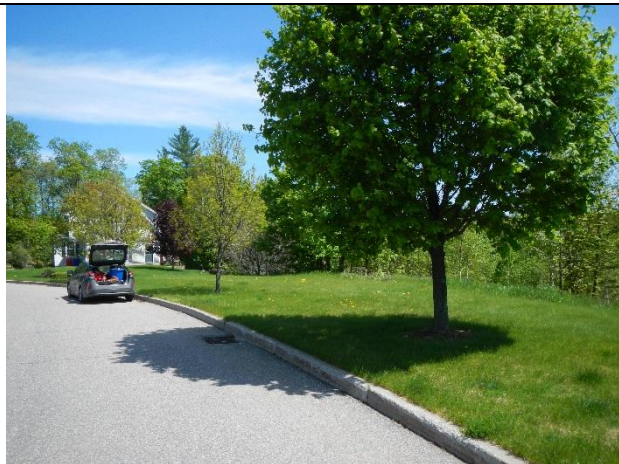
**Photo 1:** Area for subsurface infiltration feature adjacent to catchbasin discharging east (right)

**BMP Description:** Retrofit the existing catchbasin to direct WQv to an underground treatment system in grassed area east of road

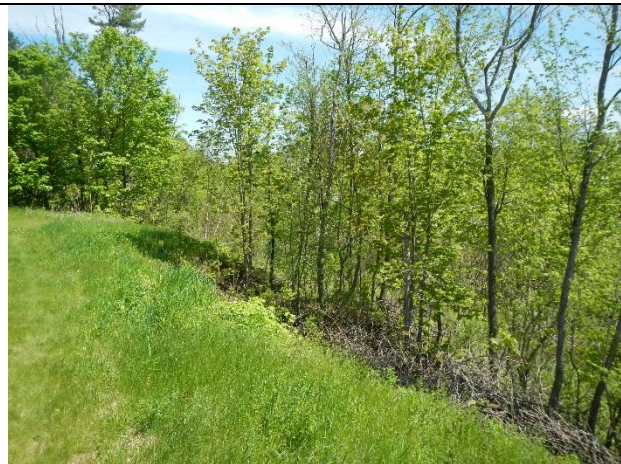
**Photo 2:** Steep slope east of the proposed subsurface treatment feature.

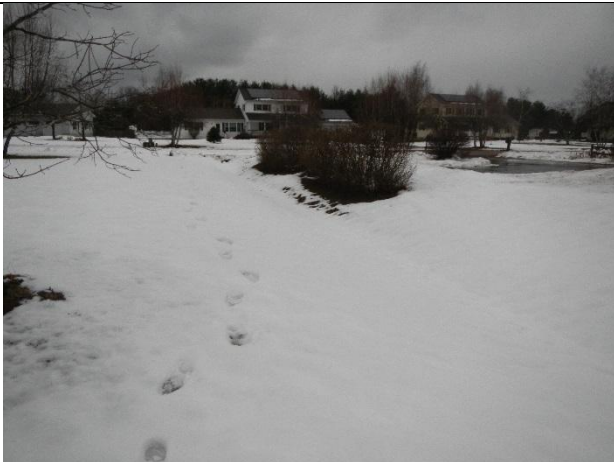
| Project: BB-1 | | Problem Area Summary | | | | |
|---|---|---|---|---|---|---|
| Photo 1: Swale from road to pond | | Photo 2: Swale flows through a small forested area with pond in the background | | | | |

| Project: BB-1 | | Problem Area Summary | | | | |
|---|---|---|---|---|---|---|
| <p><b>BMP Description:</b> Widen the swale and install check dams to increase water storage volume to infiltrate most of the WQv.</p> | | | | | | |

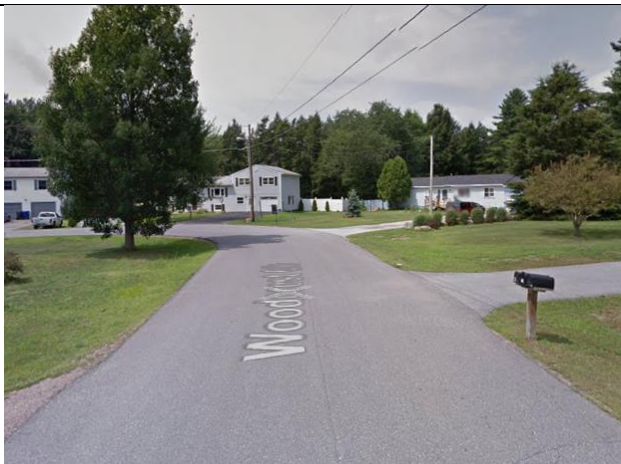
**Site Description:** Two existing dry wells are likely insufficient for the size of the drainage area along the northern portion of Woodcrest Cir. Both dry wells have some pre-treatment from grassed swales. All runoff eventually infiltrates with the existing system.

**Photo 1:** Location of proposed dry wells (Picture from Google Street View)

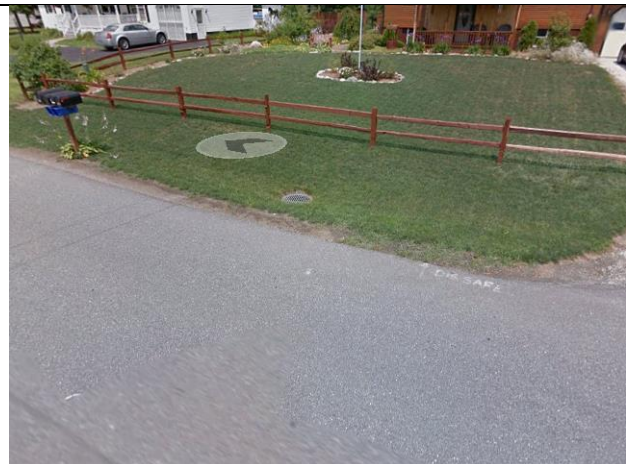
**Photo 2:** Existing dry well with grassed swale pre-treatment (Picture from Google Street View)

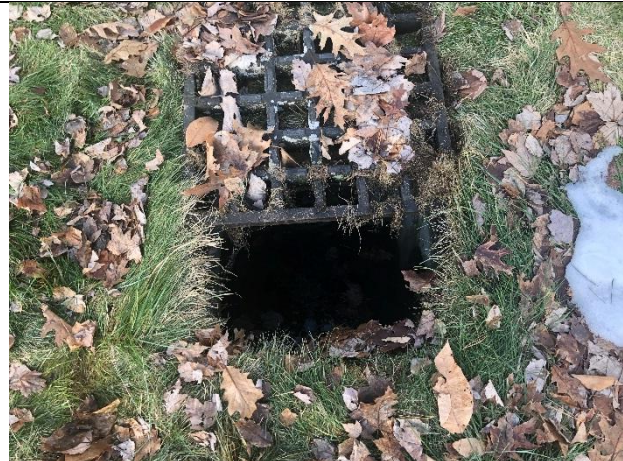
**Photo 2:** New 4-way shallow catch basin

**BMP Description:** All 6-7 of the dry wells in the existing drainage network should be drained and cleaned. We expect that several of these should be replaced. Pre-treatment (deep sump catch basin) should be incorporated into any dry well replacements, or retrofits if possible. A large new dry well should replace the catch basin north of Hemlock Road. The overflow pipe from the 3 dry wells should be routed to the newer existing dry well north of Hemlock Road. The outlet pipe to the south should be cleaned or replaced.

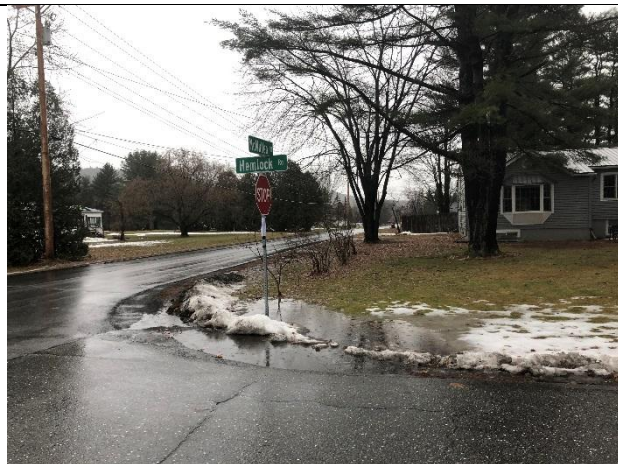
| Project: BB-4 | | Problem Area Summary | | | | |
|---|---|---|---|---|---|---|
| <p><b>Site Description:</b> Two dry wells located at the intersection of Hemlock and McMullen are under performing, leading to frequent and sustained ponding at the intersection.</p> | | | | | | |
| <p><b>Photo 1:</b> Location of proposed grass ditch along Hemlock Rd</p> <p><b>Photo 2:</b> Ponding 6" over dry well during a small runoff event</p> | | | | | | |

| Project: BB-4 | | Problem Area Summary | | | | |
|---|---|---|---|---|---|---|
| <p><b>BMP Description:</b> Install grassed ditches on both sides of Hemlock Road to improve infiltration and function as pre-treatment. The ditch on the south side will require 2 driveway culverts. The two dry wells likely need to be replaced.</p> | | | | | | |

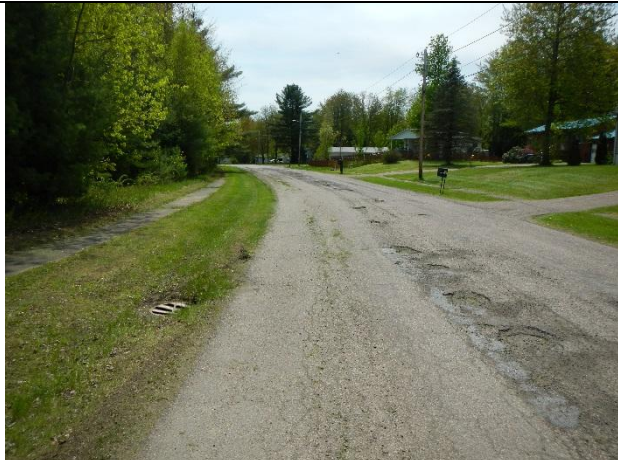
| Project: BB-5 | | Problem Area Summary | | | | |
|---|---|---|---|---|---|---|
| <b>Site Description:</b> High water table caused significant damage to the paved road winter 2018/2019. Existing road drainage is poor in the northern section, stormwater is collected in two catchbasins and piped north to the stream. | | | | | | |
| <b>Photo 1:</b> Potholes and pavement damage in low point of road at catch basins. | | <b>Photo 2:</b> Gravel and grass shoulder along the west side of Kingswood Drive provides some room for stormwater treatment. | | | | |

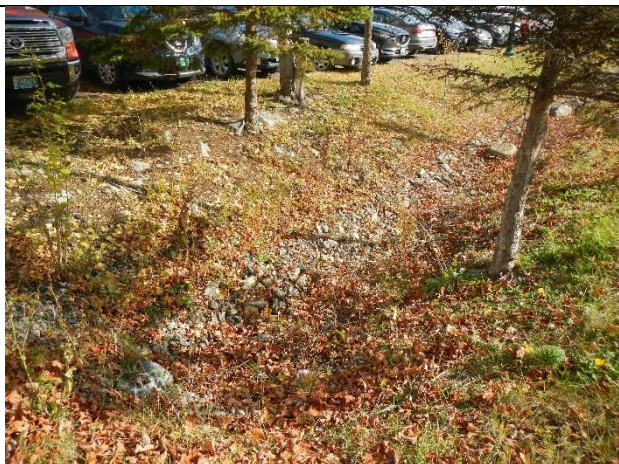
| Project: H-1 | | Problem Area Summary | | | | |
|---|---|---|---|---|---|---|
| <p><b>Photo 1:</b> Stone lined swale between parking lots</p> | | <p><b>Photo 2:</b> Existing swale outlet limits ponding and retention</p> | | | | |

| Project: H-1 | | Problem Area Summary | | | | |
|---|---|---|---|---|---|---|
| <p><b>BMP Description:</b> Retrofit the outlet of each swale to increase ponding volume and retention time. Additional check dams will be necessary to maximize treatment volume. Each swale could be regraded to increase volume. Plantings or reduced mowing are recommended to improve nutrient removal.</p> | | | | | | |

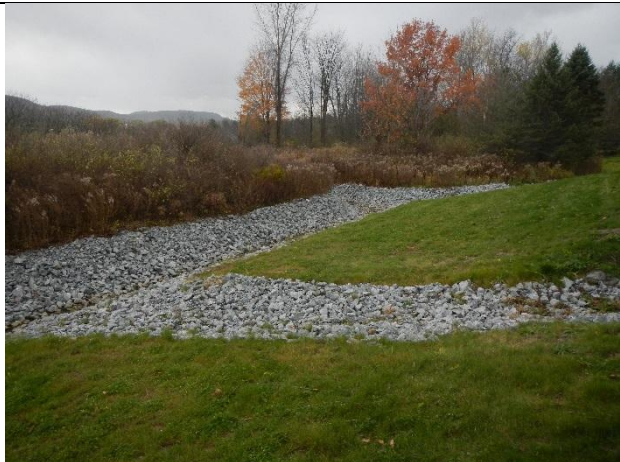
| Project: H-4 | | Problem Area Summary | | | | |
|---|---|---|---|---|---|---|
| <p><b>Site Description:</b> The large parking area drains to a steep grassed bank and into an oversized stone lined swale flowing southwest along the railroad tracks. The swale empties into a vegetated ditch along the west side of the railroad tracks.</p> | | | | | | |
| <p><b>Photo 1:</b> Northeast end of stone swale and outlet structure with overflow from wet pond.</p> | | <p><b>Photo 2:</b> Outlet from wet pond draining to the southern end of the stone lined swale.</p> | | | | |

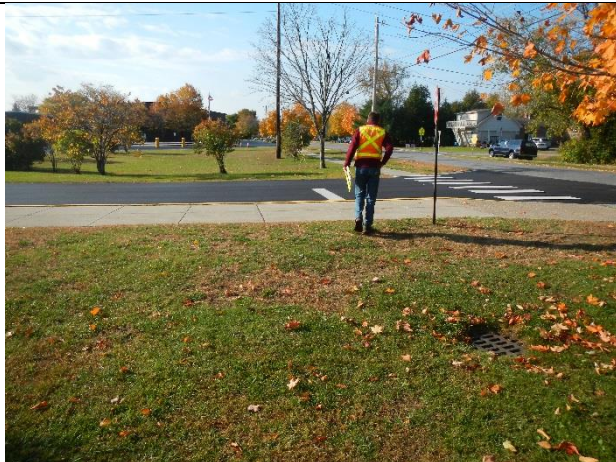
| Project: MSD-1 | | Problem Area Summary | | | | |
|---|---|---|---|---|---|---|
| Photo 1: Parking lot draining to project area | | Photo 2: Catch basin draining south to large dry well and stream | | | | |

| Project: MSD-1 | | Problem Area Summary | | | | |
|---|---|---|---|---|---|---|
| <b>BMP Description:</b> Install a surface infiltration area with an overflow to the existing catch basin. Catch basin could be retrofitted to raise elevation or infiltration area could be designed to pond above the catch basin rim with a stable overflow. Plantings should be included to enhance the educational and aesthetic benefits of the project. | | | | | | |

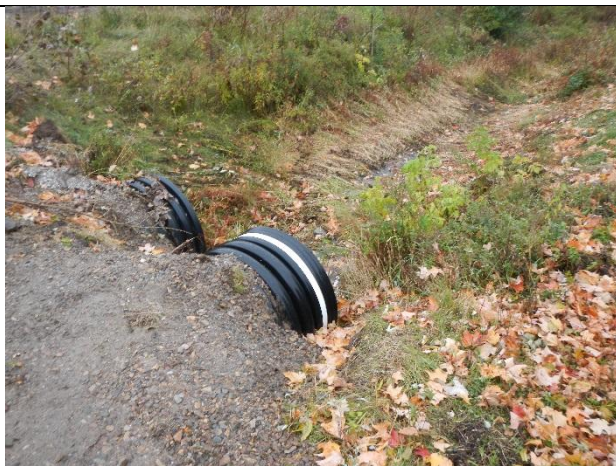
| Project: O-1 | | Problem Area Summary | | | | |
|---|---|---|---|---|---|---|
| <b>Site Description:</b> A long roadside ditch/swale along the east side of North Road collects runoff from portions of the roadway and from a large agricultural field and dairy barn to the east. Several intermittent stream channels drain to the ditch and moderate to severe erosion was observed along the ditch at a farm road access. Vegetation cover was fair to good for most of the ditch, with some areas of ditch erosion. | | | | | | |
| <b>Photo 1:</b> Ditch looking south from farm road crossing | | <b>Photo 2:</b> Erosion on farm road crossing | | | | |

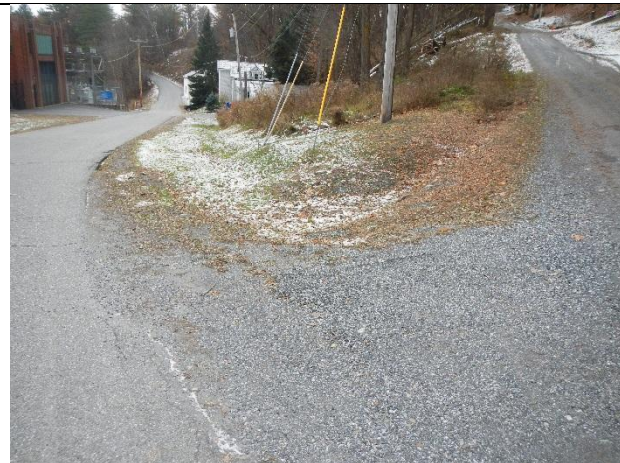
**Site Description:** A steep gravel road (Crest Dr – Private) drains onto a town road (Howard Dr). A very steep turn at the intersection and poor grading directs runoff onto Howard Drive partially bypassing the grassed ditch. High sediment loads are delivered from Crest Dr and additional erosion was observed along Howard. The runoff flows down Howard or re-enters the ditch and is conveyed directly to the River through a cross-culvert.

**Photo 1:** Sharp bend at bottom of Crest Dr, runoff flows on to Howard Dr

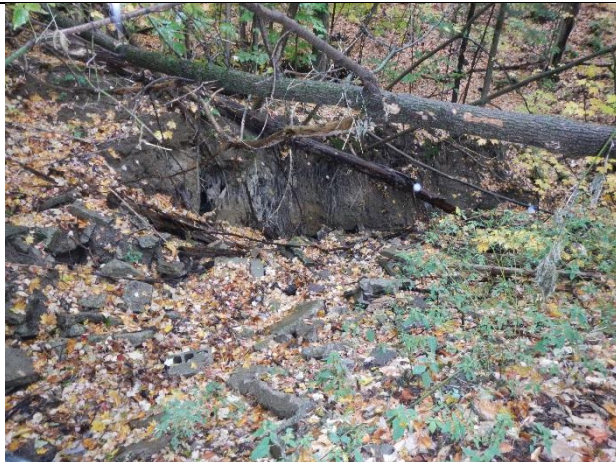
| Project: RR-2 | | Problem Area Summary | | | | |
|---|---|---|---|---|---|---|
| <b>Site Description:</b> Runoff from a large parking area joins a small tributary piped under the parking lot at the southwest corner of the parking lot. A large gully has formed and continues south to a small perennial stream. | | | | | | |
| <b>Photo 1:</b> Tributary flowing under parking lot to outlet at southwest corner (near car) | | <b>Photo 2:</b> Large and active gully erosion from corner of parking lot to perennial stream channel | | | | |

| Project: RR-2 | | Problem Area Summary | | | | |
|---|---|---|---|---|---|---|
| <b>BMP Description:</b> Stabilize the gully with rock and install a surface infiltration feature to capture some of the parking lot runoff. The available treatment area is very small compared to the parking lot size. <b>Further treatment is possible with underground storage; however, it would be very challenging and expensive to increase treatment volume to the WQv.</b> | | | | | | |

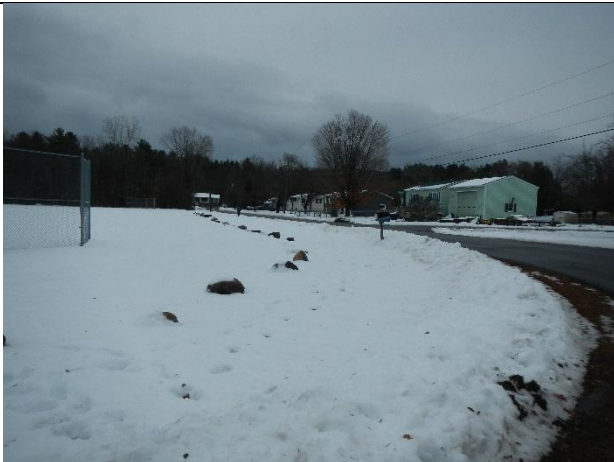
| Project: RR-8 | | Problem Area Summary | | | | |
|---|---|---|---|---|---|---|
| <b>Site Description:</b> Portions of Bradley St and most of the playing field complex drain to a grassed swale along Bradley St. A low point is located near the Vernon Ct intersection, behind home plate. All runoff appears to infiltrate in the existing swale. | | | | | | |
| <b>Photo 1:</b> Grassy swale along Bradley Ave with a low point on bend. | | | | | | |

| Project: RR-8 | | Problem Area Summary | | | | |
|---|---|---|---|---|---|---|
| <b>BMP Description:</b> Install a small rain garden in the low area behind home plate to increase P removal. A larger rain garden could be installed, however all runoff currently infiltrates in the existing swale. | | | | | | |

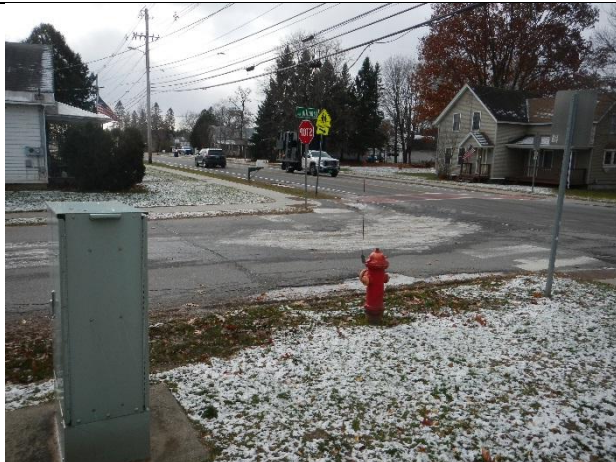
| Project: RT7-4 | | Problem Area Summary | | | | |
|---|---|---|---|---|---|---|
| <b>Site Description:</b> The intersection of Lamoille Terrace and Route 7 lacks appropriate drainage infrastructure. Runoff ponds on Lamoille Terrace and eventually infiltrates into the adjacent grassed areas. This intersection is a recurring issue for the Public Works Department, especially during winter months. | | | | | | |
| <b>Photo 1:</b> 3 Culvert under entrance to storage facility | | <b>Photo 2:</b> Runoff ponding on sidewalk along Checkerberry. | | | | |

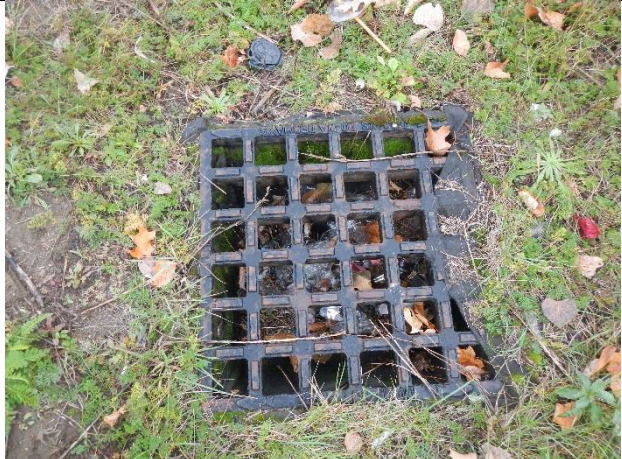
| Project: RT7-7 | | Problem Area Summary | | | | |
|---|---|---|---|---|---|---|
| Photo 1: Grassed basin looking north from Route 7 | | Photo 2: Fabric filter installed under catch basin grate | | | | |

| Project: RT7-7 | | Problem Area Summary | | | | |
|---|---|---|---|---|---|---|
| <p><b>BMP Description:</b> Install earthen/stone check dams and raise the outlet elevation by 1 foot to increase water storage volume and detention time. Side slopes should be stabilized and revegetated as needed. The outlet grate could be replaced with a beehive grate or similar structure to reduce the risk of blockage from trash and debris. <b>Full WQv treatment may be possible if depth to SHWT is sufficient to include subsurface storage and infiltration. The existing Hannafords stormwater permit should be reviewed in more detail to determine whether this area is already treated for WQv.</b></p> | | | | | | |

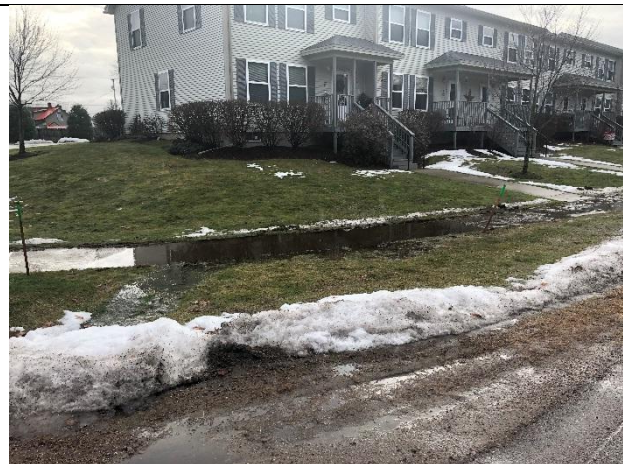
**Site Description:** A gully has formed where a cross culvert and roadside ditch drain to a small perennial stream. Checkerberry street has inadequate drainage with significant ponding along the southern side during runoff events. Nancy Drive has limited areas of grassed shoulder, runoff primarily flows down the roadway.

**Photo 2:** Runoff ponding on sidewalk along Checkerberry.

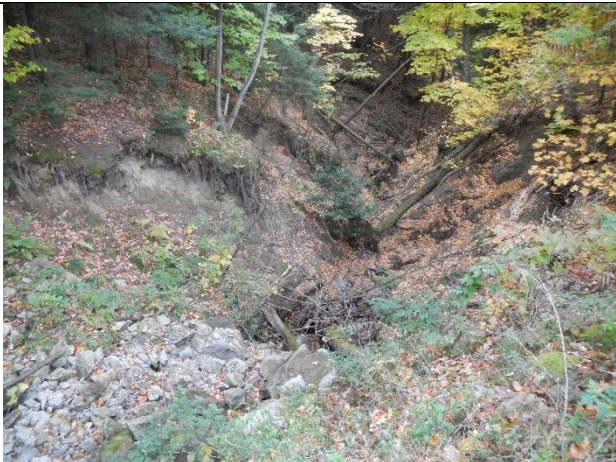
| Project: SS-1 | | Problem Area Summary | | | | |
|---|---|---|---|---|---|---|
| <b>Site Description:</b> The road surfaces and some of the houses and driveways along Stacy Street drain to a simple storm drainage system with a single outlet pipe south of the Edward St intersection. The runoff from this neighborhood has caused a very large gully to form. | | | | | | |
| <b>Photo 1:</b> Large and active gully at the outlet of the Stacy St storm drainage system | | | | | | |

| Project: SS-1 | | Problem Area Summary | | | | |
|---|---|---|---|---|---|---|
| <b>BMP Description:</b> Replace existing catch basins with dry wells and install a new underground infiltration practice between the roadway and the gully. May be possible to reroute some of the runoff north into the Edward St drainage system, if this will not cause additional water quality issues. | | | | | | |

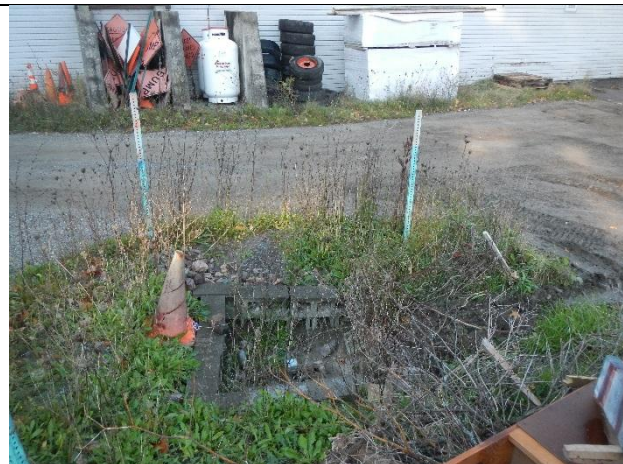
**Site Description:** The back half of the Town garage drains onto a large gravel parking area with additional road sand and other materials stored nearby. Runoff flows to a single catch basin which is piped southwest and empties directly into the River. Rill erosion was observed at the catch basin inlet.

**Photo 2:** Deep catch basin with erosion

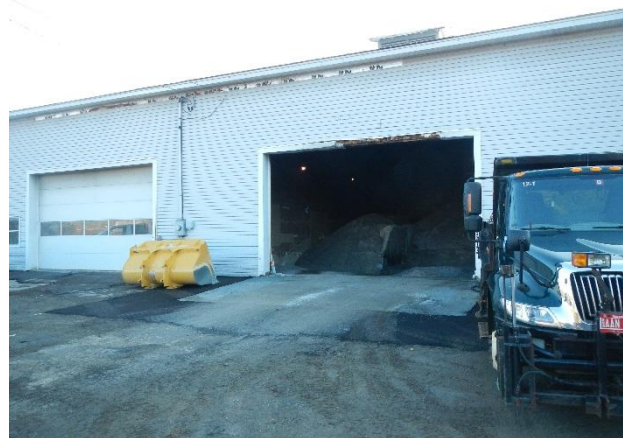
**Photo 2:** Roof drains onto parking area with high sediment and salt loads

**BMP Description:** Install a sediment trap and surface infiltration feature in grassed area between parking lot and steep cliff to river. Divert roof runoff way from salt loading area. A grassed filter strip should be maintained along the edge of the parking area for pre-treatment.

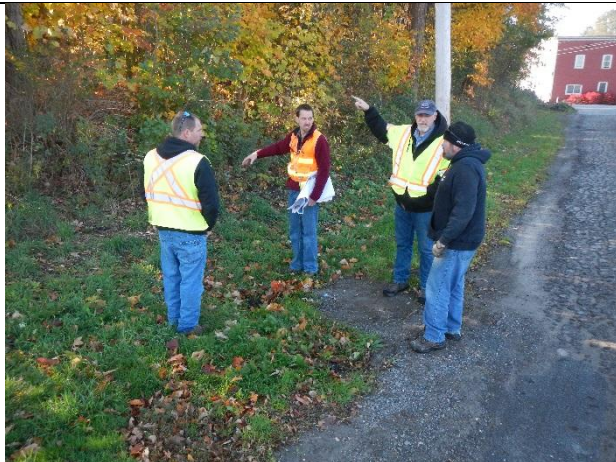
| Project: TP-3 | | Problem Area Summary | | | | |
|---|---|---|---|---|---|---|
| <p><b>Photo 1:</b> Flow path from parking lot</p> | | <p><b>Photo 2:</b> Roof drains onto parking area with high sediment and salt loads</p> | | | | |

| Project: TP-3 | | Problem Area Summary | | | | |
|---|---|---|---|---|---|---|
| <p><b>BMP Description:</b> Install a small infiltration basin and sediment trap around the existing catch basin. May be able to raise the catch basin some to increase treatment volume. Bedrock is likely a constraint for underground detention.</p> | | | | | | |

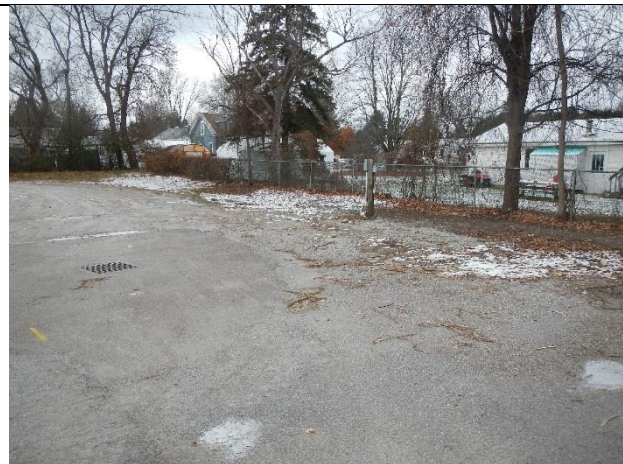
**Photo 2:** Dry well in unpaved portion of parking lot

**BMP Description:** The existing dry well likely needs to be replaced. A deep sump catch basin could be installed as an inlet pre-treatment feature. We recommend paving the remainder of the property to improve drywell function. A new dry well should be installed along the southern edge of the property. The grassed area can be graded to function as a pre-treatment swale.

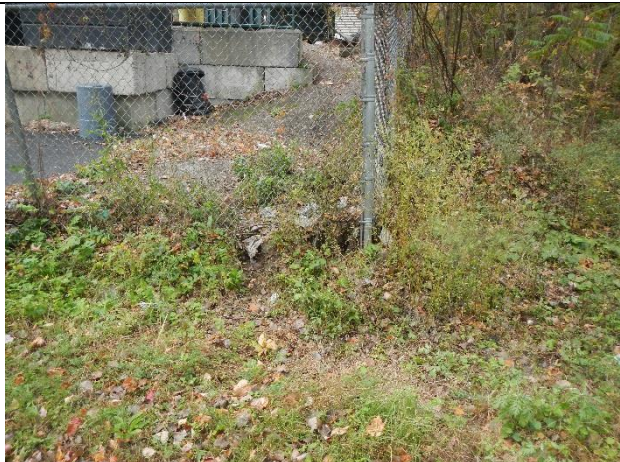
| Project: TP-6 | | Problem Area Summary | | | | |
|---|---|---|---|---|---|---|
| Photo 1: Transfer station | | Photo 2: Flow path from transfer station to ditch | | | | |

| Project: TP-6 | | Problem Area Summary | | | | |
|---|---|---|---|---|---|---|
| <p><b>BMP Description:</b> Stabilize flow path where runoff leaves the transfer station and stabilize receiving ditch. Install a cross-culvert under the gravel road, with a grassed swale at the culvert outlet. Construct a small pre-treatment forebay and an underground infiltration gallery.</p> | | | | | | |
