| Project: AB-2 | | Problem Area Summary |
| Lake Segment | Malletts Bay Direct | |
| Location | Allen Drive | |

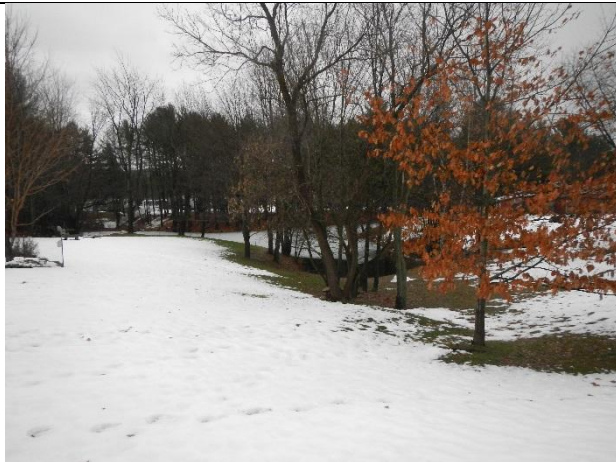
| Project: BB-1 | | Problem Area Summary | | | | |
|---|---|---|---|---|---|---|
| Project Priority | High | <p><b>Site Description:</b> All paved surfaces and portions of roofs drain to grassed ditches along the road. A cross-culvert directs all runoff to a grassed swale leading to the pond.</p> | | | | |
| Photo 1: Swale from road to pond | | Photo 2: Swale flows through a small forested area with pond in the background | | | | |

| Project: BB-1 | | Problem Area Summary | | | | |
|---|---|---|---|---|---|---|
| <p><b>BMP Description:</b> Widen the swale and install check dams to increase water storage volume to infiltrate most of the WQv.</p> | | | | | | |

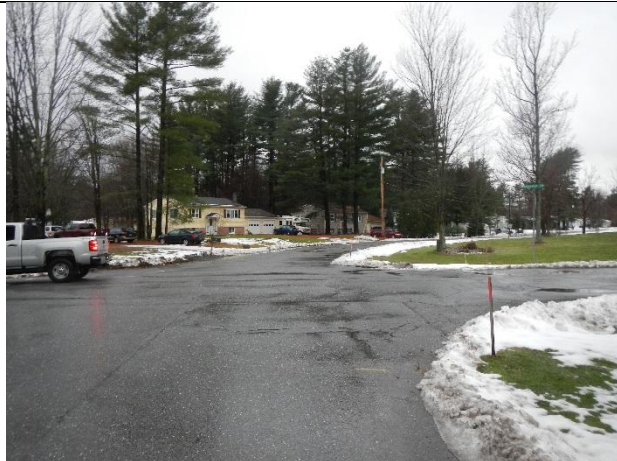
**Site Description:** A pair of dry wells (DW) located at Griswold and Woodcrest have an outlet pipe draining south to a new catch basin north of Hemlock Rd. This basin and three dry wells located at Woodcrest and Hemlock all connect to a pair of dry wells on Hemlock Rd. The DW south of Hemlock is old and appears to be non-functioning. This dry well has an overflow culvert to a swale south of the houses, the culvert is likely plugged or crushed, restricting flow. All existing dry wells take direct runoff with no pre-treatment.

**Photo 1:** 3 dry wells at Hemlock/Woodcrest

**BMP Description:** All 6-7 of the dry wells in the existing drainage network should be drained and cleaned. We expect that several of these should be replaced. Pre-treatment (deep sump catch basin) should be incorporated into any dry well replacements, or retrofits if possible. A large new dry well should replace the catch basin north of Hemlock Road. The overflow pipe from the 3 dry wells should be routed to the newer existing dry well north of Hemlock Road. The outlet pipe to the south should be cleaned or replaced.

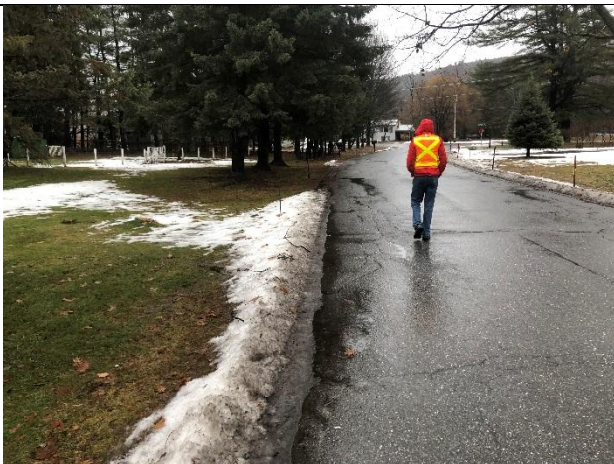
| Project: BB-4 | | Problem Area Summary | | | | |
|---|---|---|---|---|---|---|
| <p><b>Site Description:</b> Two dry wells located at the intersection of Hemlock and McMullen are under performing, leading to frequent and sustained ponding at the intersection.</p> | | | | | | |
| <p><b>Photo 1:</b> Location of proposed grass ditch along Hemlock Rd</p> <p><b>Photo 2:</b> Ponding 6" over dry well during a small runoff event</p> | | | | | | |

| Project: BB-4 | | Problem Area Summary | | | | |
|---|---|---|---|---|---|---|
| <p><b>BMP Description:</b> Install grassed ditches on both sides of Hemlock Road to improve infiltration and function as pre-treatment. The ditch on the south side will require 2 driveway culverts. The two dry wells likely need to be replaced.</p> | | | | | | |

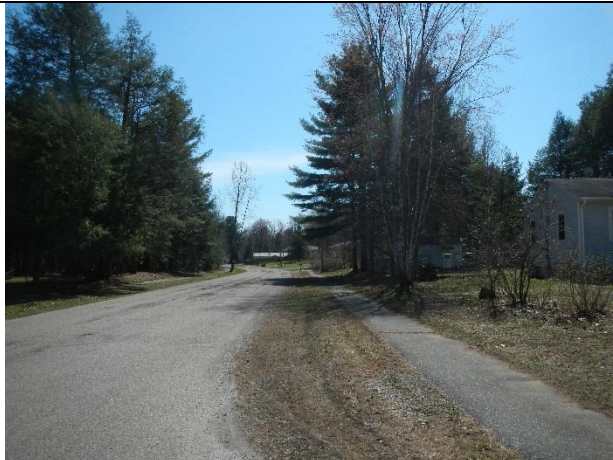
| Project: BB-5 | | Problem Area Summary | | | | |
|---|---|---|---|---|---|---|
| <b>Site Description:</b> High water table caused significant damage to the paved road winter 2018/2019. Existing road drainage is poor in the northern section, stormwater is collected in two catchbasins and piped north to the stream. | | | | | | |
| <b>Photo 1:</b> Potholes and pavement damage in low point of road at catch basins. | | <b>Photo 2:</b> Gravel and grass shoulder along the west side of Kingswood Drive provides some room for stormwater treatment. | | | | |

| Project: BB-5 | | Problem Area Summary | | | | |
|---|---|---|---|---|---|---|
| <b>BMP Description:</b> Improve road drainage and install shallow sand filters along road shoulder. | | | | | | |

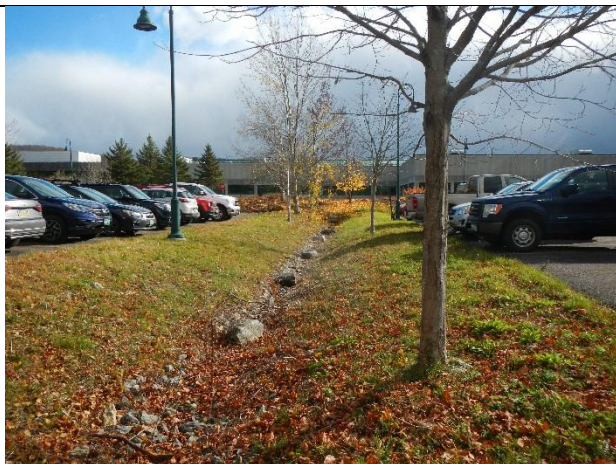
| Project: H-1 | | Problem Area Summary | | | | |
|---|---|---|---|---|---|---|
| <p><b>Site Description:</b> Three grassed and stone lined swales are located between employee parking areas. All three appear to receive additional runoff from catchbasins along the main road. The swales all drain to culverts located at grade and outlet northwest to a wetland area. Curb cuts and sheetflow convey runoff from the parking areas to the swales with no visible erosion.</p> | | | | | | |
| <p><b>Photo 1:</b> Stone lined swale between parking lots</p> | | <p><b>Photo 2:</b> Existing swale outlet limits ponding and retention</p> | | | | |

| Project: H-1 | | Problem Area Summary | | | | |
|---|---|---|---|---|---|---|
| <p><b>BMP Description:</b> Retrofit the outlet of each swale to increase ponding volume and retention time. Additional check dams will be necessary to maximize treatment volume. Each swale could be regraded to increase volume. Plantings or reduced mowing are recommended to improve nutrient removal.</p> | | | | | | |

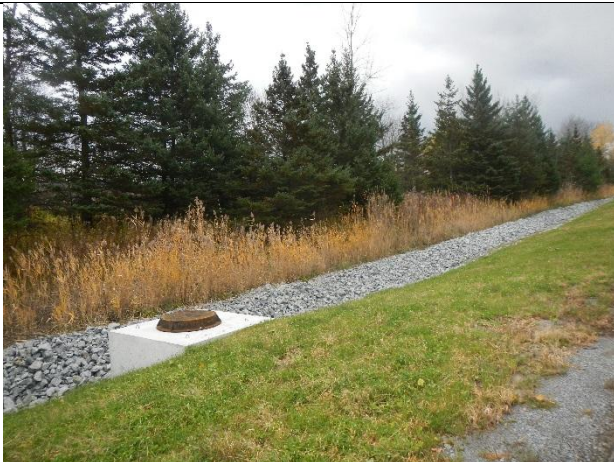
| Project: H-4 | | Problem Area Summary | | | | |
|---|---|---|---|---|---|---|
| <p><b>Site Description:</b> The large parking area drains to a steep grassed bank and into an oversized stone lined swale flowing southwest along the railroad tracks. The swale empties into a vegetated ditch along the west side of the railroad tracks.</p> | | | | | | |
| <p><b>Photo 1:</b> Northeast end of stone swale and outlet structure with overflow from wet pond.</p> | | <p><b>Photo 2:</b> Outlet from wet pond draining to the southern end of the stone lined swale.</p> | | | | |

| Project: H-4 | | Problem Area Summary | | | | |
|---|---|---|---|---|---|---|
| <p><b>BMP Description:</b> Add a series of check dams or weirs to increase water storage capacity and detention times within the existing swale. Sufficient treatment volume is likely available to meet WQv and CPv treatment requirements. A stabilized overflow is required at the end of the swale and additional stabilization may be necessary along the railroad ditch.</p> | | | | | | |

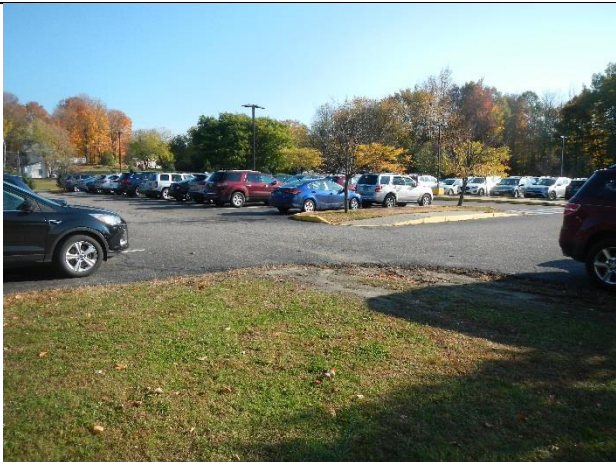
| Project: MSD-1 | | Problem Area Summary | | | | |
|---|---|---|---|---|---|---|
| <b>Site Description:</b> A portion of a large parking lot drains southwest to a small grassed area with a catch basin. Runoff is piped south to the large dry well with an overflow into the stream to the west (project MSD-2). | | | | | | |
| Photo 1: Parking lot draining to project area | | Photo 2: Catch basin draining south to large dry well and stream | | | | |

| Project: MSD-1 | | Problem Area Summary | | | | |
|---|---|---|---|---|---|---|
| <b>BMP Description:</b> Install a surface infiltration area with an overflow to the existing catch basin. Catch basin could be retrofitted to raise elevation or infiltration area could be designed to pond above the catch basin rim with a stable overflow. Plantings should be included to enhance the educational and aesthetic benefits of the project. | | | | | | |

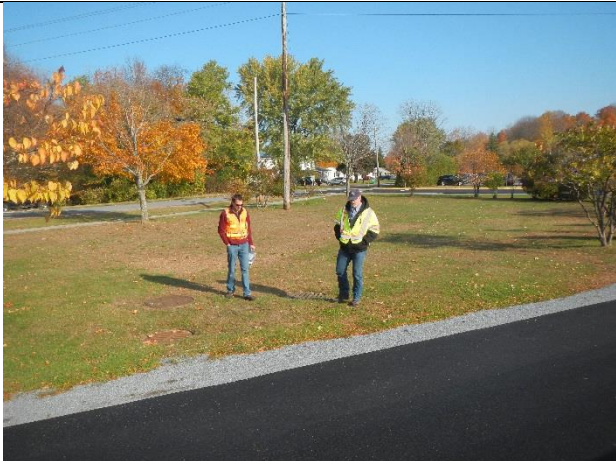
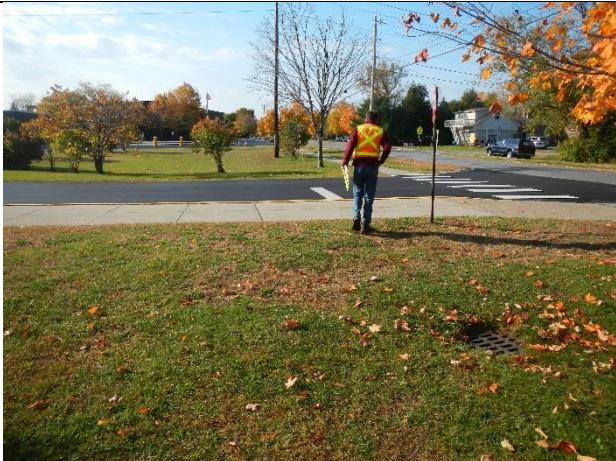
| Project: MSD-2 | | Problem Area Summary | | | | |
|---|---|---|---|---|---|---|
| <p><b>Site Description:</b> The Milton Elementary School property drains to a network of catch basins and dry wells that all connect to a single large dry well in a grassed area by the school entrance. This dry well has a large overflow culvert to the perennial stream channel west of Herrick Ave. Given the large drainage area and the limited storage depth in the drywell below the overflow pipe, it is unlikely the dry well can handle much of the WQV storm before overflowing to the nearby stream.</p> | | | | | | |
| <div><div></div><div></div></div> <p><b>Photo 1:</b> Grassed area at school entrance with multiple dry wells and catch basins</p> <p><b>Photo 2:</b> Catch basin connecting north parking areas to main drainage system</p> | | | | | | |

| Project: MSD-2 | | Problem Area Summary | | | | |
|---|---|---|---|---|---|---|
| <p><b>BMP Description:</b> Install a large underground infiltration system in the grassed area adjacent to the existing drainage network. Retrofits to the existing drainage network may be required to adjust water elevations and to direct a portion of the runoff to the new infiltration feature. Existing closed drainage system needs to be better mapped/understood to determine required treatment volumes and benefits/costs.</p> | | | | | | |

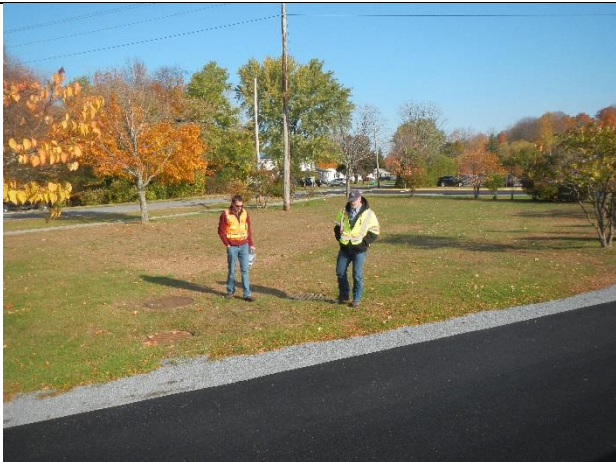
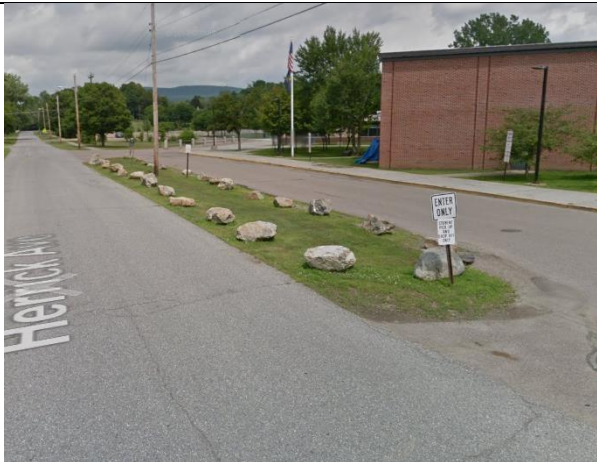
| Project: MSD-3 | | Problem Area Summary | | | | |
|---|---|---|---|---|---|---|
| <b>Site Description:</b> Runoff from two sections of the school entrance roadway sheetflow to grassed areas with catch basins connected to the main drainage network. No erosion was observed in either area. Both areas are highly visible. | | | | | | |
| <b>Photo 1:</b> Grassed area along inside of curved entrance road (6a) | | <b>Photo 2:</b> Grassed area along Herrick Ave (photo from Google Street View) | | | | |

| Project: MSD-3 | | Problem Area Summary | | | | |
|---|---|---|---|---|---|---|
| <b>BMP Description:</b> Install bioswale or other linear rain garden type feature along the edge of each paved area. For 6a it is recommended to leave a bench of grassed area to serve as a snow shelf. Bioswales should be designed for infiltration and planted with native vegetation. | | | | | | |

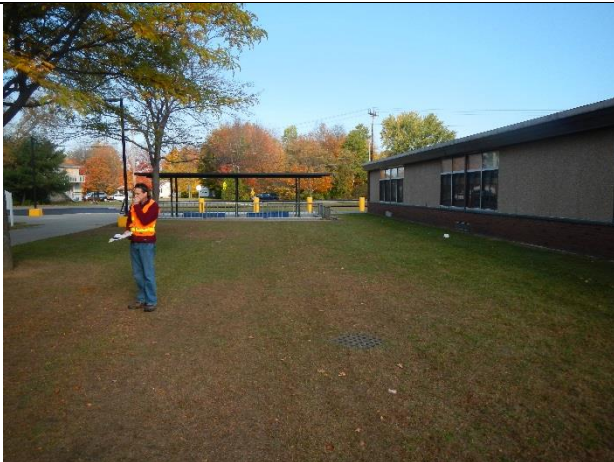
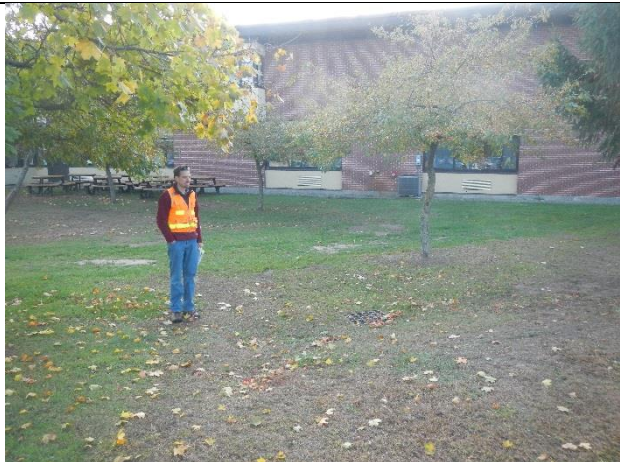
| Project: MSD-4 | | Problem Area Summary | | | | |
|---|---|---|---|---|---|---|
| <b>Site Description:</b> Two catchbasins receive runoff from rooftop and paved sidewalk areas. Both basins are connected to the main drainage network (project MSD-2). Both basins are in highly visible locations, 4a is in the grassed area along the main entrance to the school. | | | | | | |
| Photo 1: Catchbasin by main entrance (4a) | | Photo 2: Catch basin along sidewalk in grassed area (4b) | | | | |

| Project: MSD-4 | | Problem Area Summary | | | | |
|---|---|---|---|---|---|---|
| <b>BMP Description:</b> Install small rain garden features in a depression around each existing catchbasin. New rain garden features at each catch basin will increase sediment and nutrient retention and provide some additional infiltration. Minor modifications to the catchbasin may be necessary. | | | | | | |

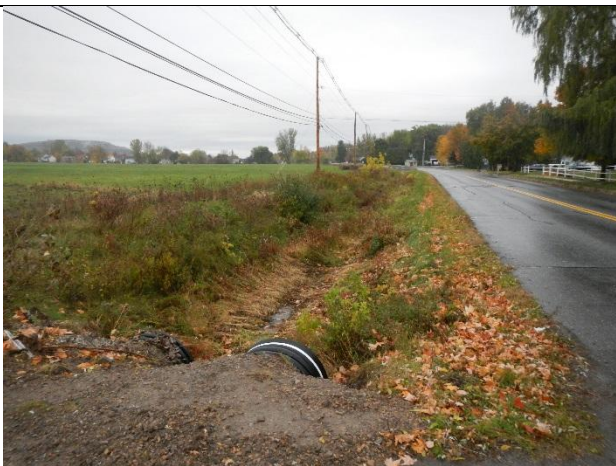
| Project: O-1 | | Problem Area Summary | | | | |
|---|---|---|---|---|---|---|
| <b>Site Description:</b> A long roadside ditch/swale along the east side of North Road collects runoff from portions of the roadway and from a large agricultural field and dairy barn to the east. Several intermittent stream channels drain to the ditch and moderate to severe erosion was observed along the ditch at a farm road access. Vegetation cover was fair to good for most of the ditch, with some areas of ditch erosion. | | | | | | |
| <b>Photo 1:</b> Ditch looking south from farm road crossing | | <b>Photo 2:</b> Erosion on farm road crossing | | | | |

| Project: O-1 | | Problem Area Summary | | | | |
|---|---|---|---|---|---|---|
| <b>BMP Description:</b> Farm road crossing should be stabilized and improved to reduce sediment loading (a). Water volume storage and treatment can be increased in the large ditch with check dam installation and improved vegetation coverage (b). Erosion areas on both sides of the North Rd culvert should be stabilized. | | | | | | |

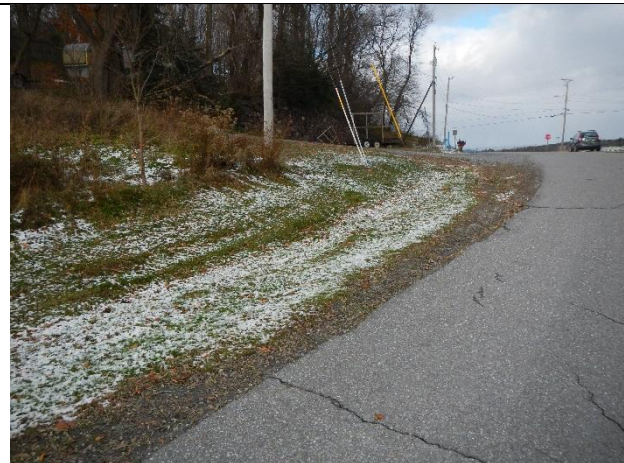
**Photo 2:** Grassed ditch along Howard Drive

**BMP Description:** Improve the grassed swale running south along Howard Drive. Check dams and reduced mowing will increase retention of water and sediment. Install a small sediment basin at the intersection. **The ditch along Crest Dr should be stone lined, however this is not included as part of this project.**

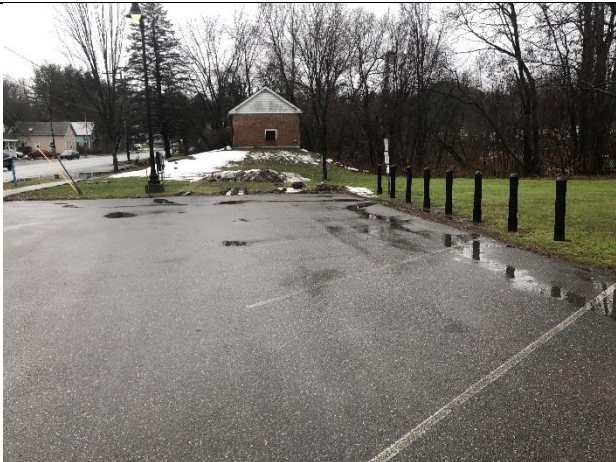
| Project: O-6 | | Problem Area Summary | | | | |
|---|---|---|---|---|---|---|
| <b>Site Description:</b> The parking area for the River Street Park and a small portion of Route 7 drain to a grassed area off the southwest corner of the parking area. Runoff sheet flows directly to the perennial stream and into the River. | | | | | | |
| <b>Photo 1:</b> Runoff draining to southwest corner of parking area | | <b>Photo 2:</b> Location of proposed rain garden | | | | |

| Project: O-6 | | Problem Area Summary | | | | |
|---|---|---|---|---|---|---|
| <b>BMP Description:</b> Install a rain garden in the grassed area between the parking lot and stream. Soils are mapped as very well drained; therefore, we do not anticipate needing an underdrain. A stable overflow should be constructed to convey excess runoff to the stream. | | | | | | |

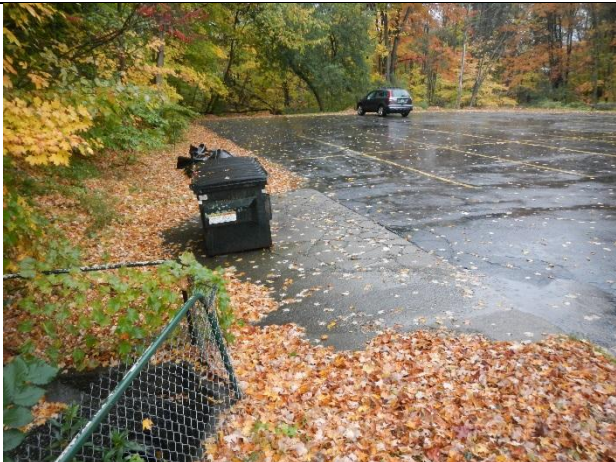
| Project: RR-2 | | Problem Area Summary | | | | |
|---|---|---|---|---|---|---|
| <b>Site Description:</b> Runoff from a large parking area joins a small tributary piped under the parking lot at the southwest corner of the parking lot. A large gully has formed and continues south to a small perennial stream. | | | | | | |
| <b>Photo 1:</b> Tributary flowing under parking lot to outlet at southwest corner (near car) | | <b>Photo 2:</b> Large and active gully erosion from corner of parking lot to perennial stream channel | | | | |

| Project: RR-2 | | Problem Area Summary | | | | |
|---|---|---|---|---|---|---|
| <b>BMP Description:</b> Stabilize the gully with rock and install a surface infiltration feature to capture some of the parking lot runoff. The available treatment area is very small compared to the parking lot size. <b>Further treatment is possible with underground storage; however, it would be very challenging and expensive to increase treatment volume to the WQv.</b> | | | | | | |

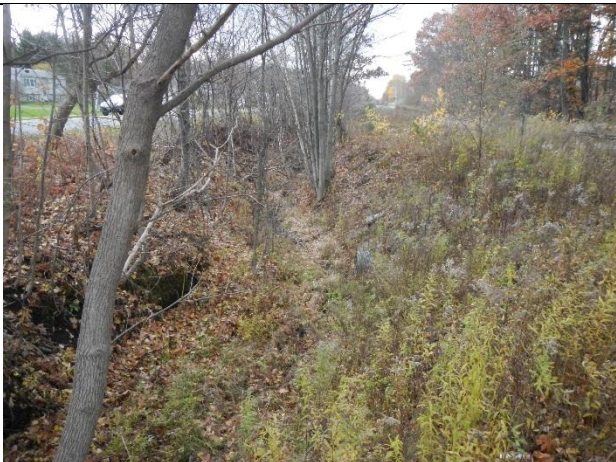
| Project: RR-5 | | Problem Area Summary | | | | |
|---|---|---|---|---|---|---|
| <p><b>Site Description:</b> A long vegetated swale between Railroad St and the railroad is mapped as having a small perennial stream channel. The swale slope is relatively flat with emergent wetland vegetation in the southern portion. The norther portion has more slope and steep forested banks. The swale crosses under the railroad and empties into a forested wetland.</p> | | | | | | |
| <p><b>Photo 1:</b> Incised channel and steep banks from the swale outlet under the railroad tracks</p> | | | | | | |

| Project: RR-5 | | Problem Area Summary | | | | |
|---|---|---|---|---|---|---|
| <p><b>BMP Description:</b> Install earthen/stone check dams to create a series of small wet ponds along the swale. The outlet culvert could be outfitted with an outlet control device to increase ponding depth and volume.</p> | | | | | | |

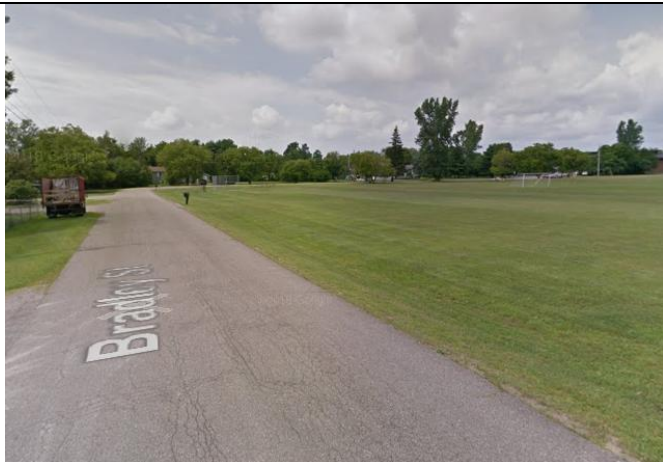
| Project: RR-8 | | Problem Area Summary | | | | |
|---|---|---|---|---|---|---|
| <b>Site Description:</b> Portions of Bradley St and most of the playing field complex drain to a grassed swale along Bradley St. A low point is located near the Vernon Ct intersection, behind home plate. All runoff appears to infiltrate in the existing swale. | | | | | | |
| <b>Photo 2:</b> Grassy swale looking west (photo from Google Street View) | | | | | | |

| Project: RR-8 | | Problem Area Summary | | | | |
|---|---|---|---|---|---|---|
| <b>BMP Description:</b> Install a small rain garden in the low area behind home plate to increase P removal. A larger rain garden could be installed, however all runoff currently infiltrates in the existing swale. | | | | | | |

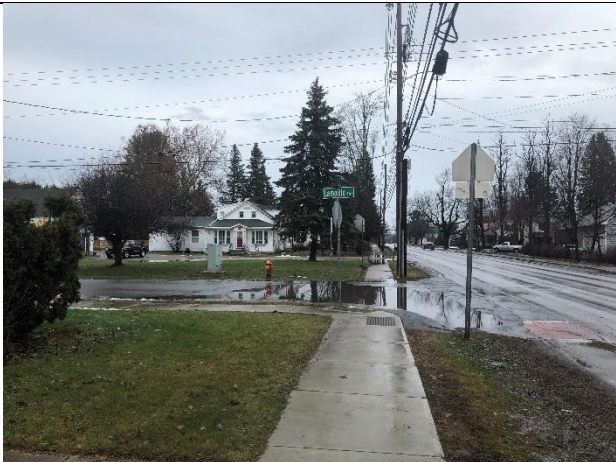
| Project: RT7-4 | | Problem Area Summary | | | | |
|---|---|---|---|---|---|---|
| <b>Site Description:</b> The intersection of Lamoille Terrace and Route 7 lacks appropriate drainage infrastructure. Runoff ponds on Lamoille Terrace and eventually infiltrates into the adjacent grassed areas. This intersection is a recurring issue for the Public Works Department, especially during winter months. | | | | | | |
| <b>Photo 1:</b> 3 Culvert under entrance to storage facility | | <b>Photo 2:</b> Runoff ponding on sidewalk along Checkerberry. | | | | |

| Project: RT7-4 | | Problem Area Summary | | | | |
|---|---|---|---|---|---|---|
| <b>BMP Description:</b> Install a catch basin along the north side of Lamoille Terrace and connect to a new dry well in the grassed area. Minor road grade adjustments will improve drainage to new catch basin. | | | | | | |

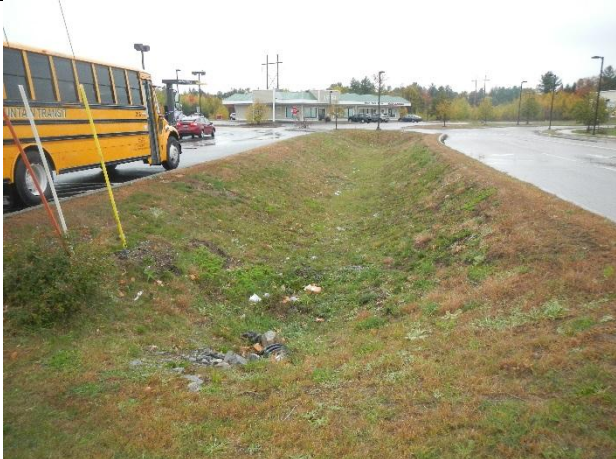
| Project: RT7-7 | | Problem Area Summary | | | | |
|---|---|---|---|---|---|---|
| <p><b>Site Description:</b> A portion of Route 7 drains to a deep grassed basin along the west side of the entrance to the shopping area. The grassed area has a roughly 0.5% slope to a recessed catch basin. The basin has steep side slopes however no significant erosion was observed. High volumes of trash were observed in the basin and trapped in the fabric filter installed under the catch basin grate. No outlet pipes are mapped, runoff may be directed to the large wet pond behind Hannafords.</p> | | | | | | |
| Photo 1: Grassed basin looking north from Route 7 | | Photo 2: Fabric filter installed under catch basin grate | | | | |

| Project: RT7-7 | | Problem Area Summary | | | | |
|---|---|---|---|---|---|---|
| <p><b>BMP Description:</b> Install earthen/stone check dams and raise the outlet elevation by 1 foot to increase water storage volume and detention time. Side slopes should be stabilized and revegetated as needed. The outlet grate could be replaced with a beehive grate or similar structure to reduce the risk of blockage from trash and debris. <b>Full WQv treatment may be possible if depth to SHWT is sufficient to include subsurface storage and infiltration. The existing Hannafords stormwater permit should be reviewed in more detail to determine whether this area is already treated for WQv.</b></p> | | | | | | |

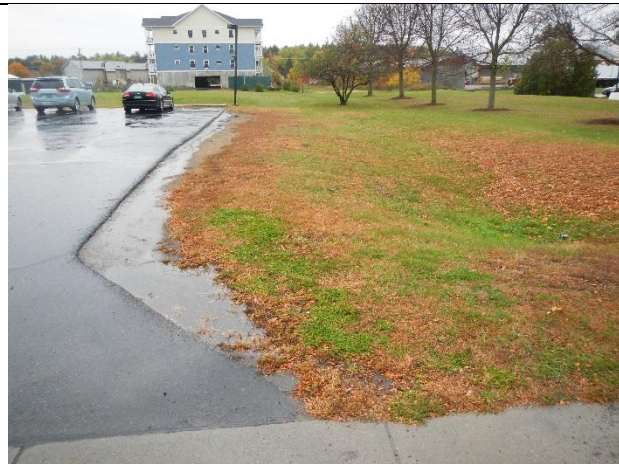
**Site Description:** The elevated grassed area along the north side of the parking entrance is preventing parking lot runoff from reaching a dry well. Runoff flows along the edge of the pavement and drains to Centre Dr. The existing dry well receives some runoff from the surrounding grassed area. Some erosion is visible along the edges of the pavement.

**Photo 1:** Grassed basin looking north from Route 7

**BMP Description:** Regrade the grassed area north of the parking lot to allow for sheetflow to the existing dry well.

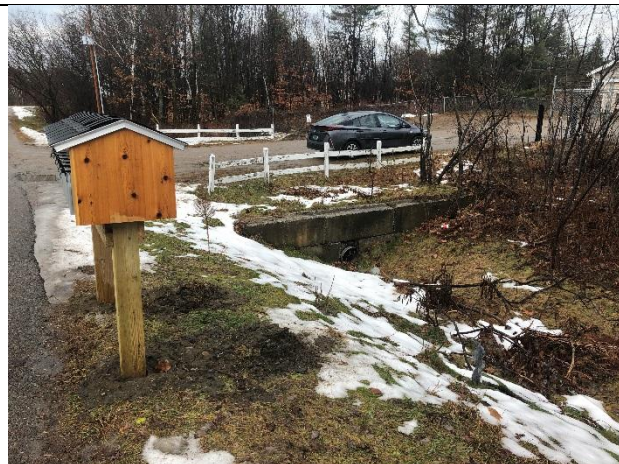
**Site Description:** A gully has formed where a cross culvert and roadside ditch drain to a small perennial stream. Checkerberry street has inadequate drainage with significant ponding along the southern side during runoff events. Nancy Drive has limited areas of grassed shoulder, runoff primarily flows down the roadway.

**Photo 1:** 3 Culvert under entrance to storage facility

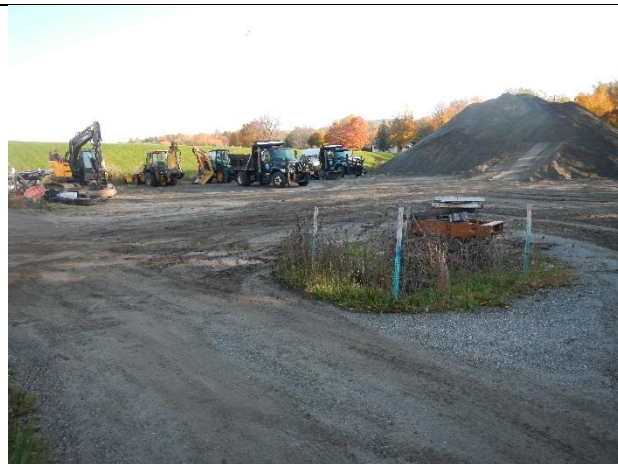
**Site Description:** The back half of the Town garage drains onto a large gravel parking area with additional road sand and other materials stored nearby. Runoff flows to a single catch basin which is piped southwest and empties directly into the River. Rill erosion was observed at the catch basin inlet.

**Photo 1:** Large gravel/dirt area draining to catch basin

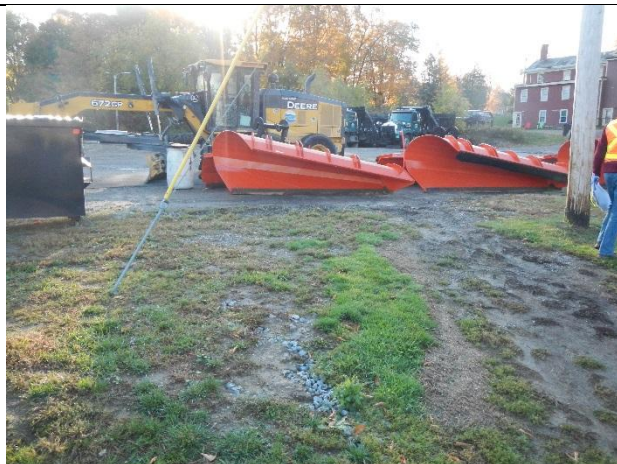
**Site Description:** The front half of the Town garage drains onto a gravel parking area. Runoff concentrates to a single flow path and empties directly into the River after flowing across a narrow grassed strip used for equipment storage. The salt storage loading area is directly under the roof drip line.

**Photo 1:** Flow path from parking lot

**BMP Description:** Install a sediment trap and surface infiltration feature in grassed area between parking lot and steep cliff to river. Divert roof runoff way from salt loading area. A grassed filter strip should be maintained along the edge of the parking area for pre-treatment.

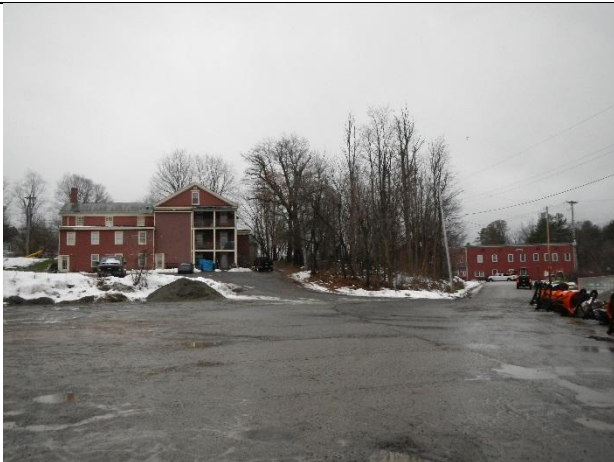
| Project: TP-3 | | Problem Area Summary | | | | |
|---|---|---|---|---|---|---|
| <p><b>Site Description:</b> Runoff from large gravel parking area (private) and portions of the paved and gravel road and parking area for the Town Garage drain to a catch basin that is piped directly to the Lamoille River.</p> | | | | | | |
| <p><b>Photo 1:</b> Flow path from parking lot</p> | | <p><b>Photo 2:</b> Roof drains onto parking area with high sediment and salt loads</p> | | | | |

| Project: TP-3 | | Problem Area Summary | | | | |
|---|---|---|---|---|---|---|
| <p><b>BMP Description:</b> Install a small infiltration basin and sediment trap around the existing catch basin. May be able to raise the catch basin some to increase treatment volume. Bedrock is likely a constraint for underground detention.</p> | | | | | | |

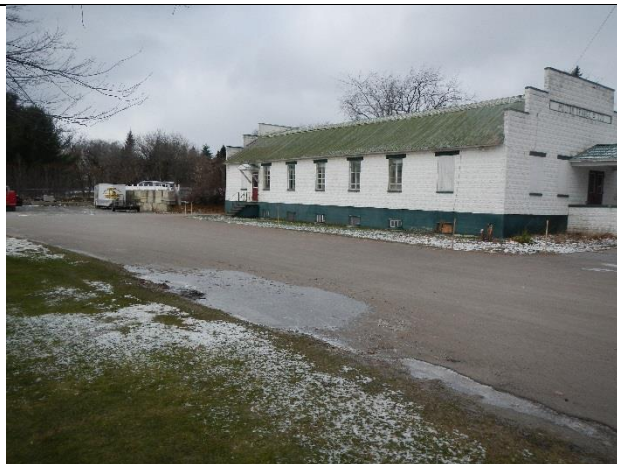
**Site Description:** The grange hall parking lot is approximately half paved and has a large dry well in the unpaved (northern) portion. Drainage is poor throughout the property and the dry well drains slowly, likely due to sediment clogging. A grassed space is located along the southern edge of the property.

**Photo 1:** Grassed area with ponded water along southern edge of parking lot

**BMP Description:** The existing dry well likely needs to be replaced. A deep sump catch basin could be installed as an inlet pre-treatment feature. We recommend paving the remainder of the property to improve drywell function. A new dry well should be installed along the southern edge of the property. The grassed area can be graded to function as a pre-treatment swale.

**Feasibility Comments:** Groundwater elevations need to be verified to ensure that dry well replacement will have sufficient depth and area to infiltrate all runoff to the site. Repaving is strongly recommended to ensure appropriate dry well function. We do not anticipate utility conflicts or permitting requirements.

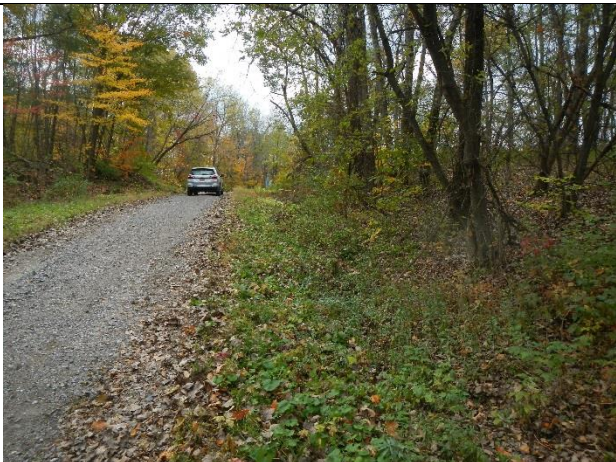
| Project: TP-5 | | Problem Area Summary | | | | |
|---|---|---|---|---|---|---|
| <p><b>Site Description:</b> An unmapped/unclassified road continuing north from the transfer station is maintained by the Town as an access to the sand and gravel storage areas by the capped landfill. The road drops at approximately 10-11% slope for a 300 ft length to the wetland complex. The road surface is poorly crowned with rill erosion and the west ditch has several areas of minor gully erosion.</p> | | | | | | |
| <p><b>Photo 1:</b> Minor gully erosion in ditch</p> <p><b>Photo 2:</b> Rill erosion on road surface</p> | | | | | | |

| Project: TP-5 | | Problem Area Summary | | | | |
|---|---|---|---|---|---|---|
| <p><b>BMP Description:</b> Improve the road crown and line the west ditch with stone for approximately 300ft of roadway length. Stabilize turnouts along the east side of road as needed.</p> | | | | | | |

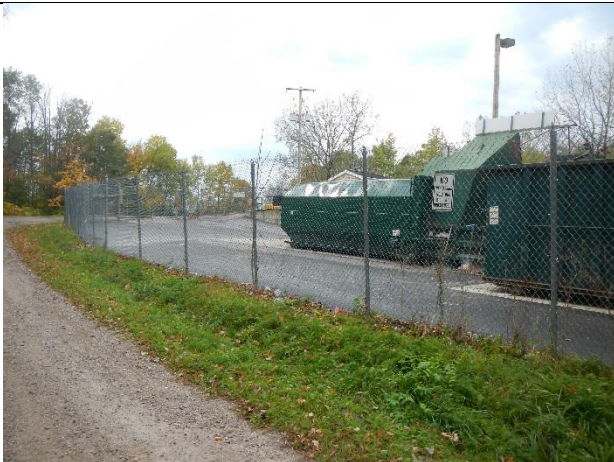
| Project: TP-6 | | Problem Area Summary | | | | |
|---|---|---|---|---|---|---|
| <p><b>Site Description:</b> The Town transfer station drains the northeast corner and flows into a road ditch. The ditch drains north down the steep slope emptying into a large wetland complex. Some erosion was visible where the runoff exits the transfer station.</p> | | | | | | |
| Photo 1: Transfer station | | Photo 2: Flow path from transfer station to ditch | | | | |

| Project: TP-6 | | Problem Area Summary | | | | |
|---|---|---|---|---|---|---|
| <p><b>BMP Description:</b> Stabilize flow path where runoff leaves the transfer station and stabilize receiving ditch. Install a cross-culvert under the gravel road, with a grassed swale at the culvert outlet. Construct a small pre-treatment forebay and an underground infiltration gallery.</p> | | | | | | |

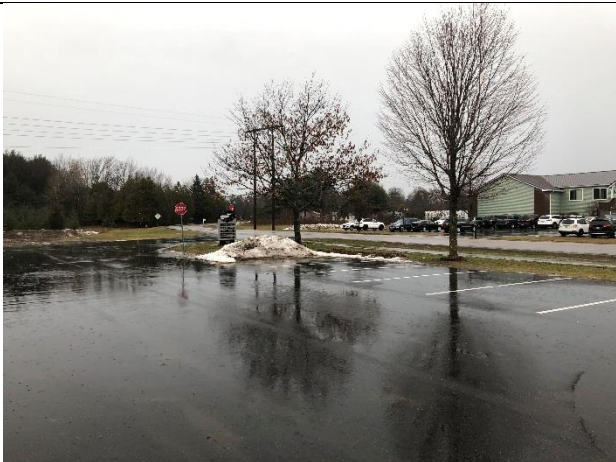
| Project: TP-7 | | Problem Area Summary | | | | |
|---|---|---|---|---|---|---|
| <b>Site Description:</b> A portion of the main parking area for the Milton municipal complex drains to a grassed area between Park Place and Bombardier Rd. | | | | | | |
| <b>Photo 1:</b> Grassed area receiving runoff from portion of parking lot | | | | | | |

| Project: TP-7 | | Problem Area Summary | | | | |
|---|---|---|---|---|---|---|
| <b>BMP Description:</b> Install a rain garden designed for infiltration. Underlying soils are mapped as having a high infiltration rate. The available footprint for treatment is relatively small, additional volume required to meet WQv (500cf) could be attained through underground storage. The existing sign and spotlights should be incorporated into the rain garden design. | | | | | | |

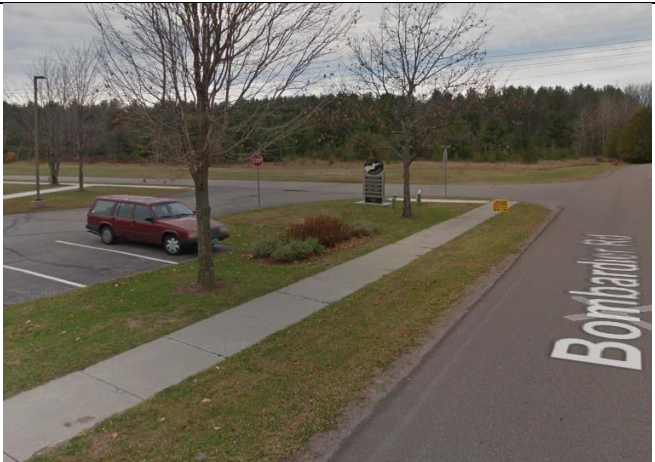
| Project: TP-7 | | Problem Area Summary | | | | |
|---|---|---|---|---|---|---|
| <b>Photo 2:</b> View of project area from Bombardier Rd (photo from Google Street View) | | | | | | |
